Jøtul F 118 CB

Woodburning Stove

Addendum to the Installation and Operation Manual cat.no. 220605

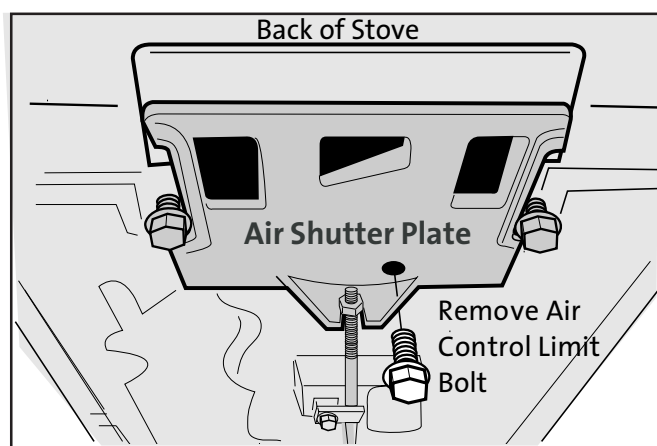
The illustration below shows the correct location of this bolt. Use a 10 mm wrench to remove it from the Air Shutter Plate underneath the back of the stove.

Figure 1 on page 5 of the manual incorrectly illustrates the location of the Air Control Limit Bolt which must be removed to operate the air control rod. The bolt location was changed after the manual went to print.
